# Delivering Land at Webheath | *Redditch Borough*

August 2011

# 1. Introduction

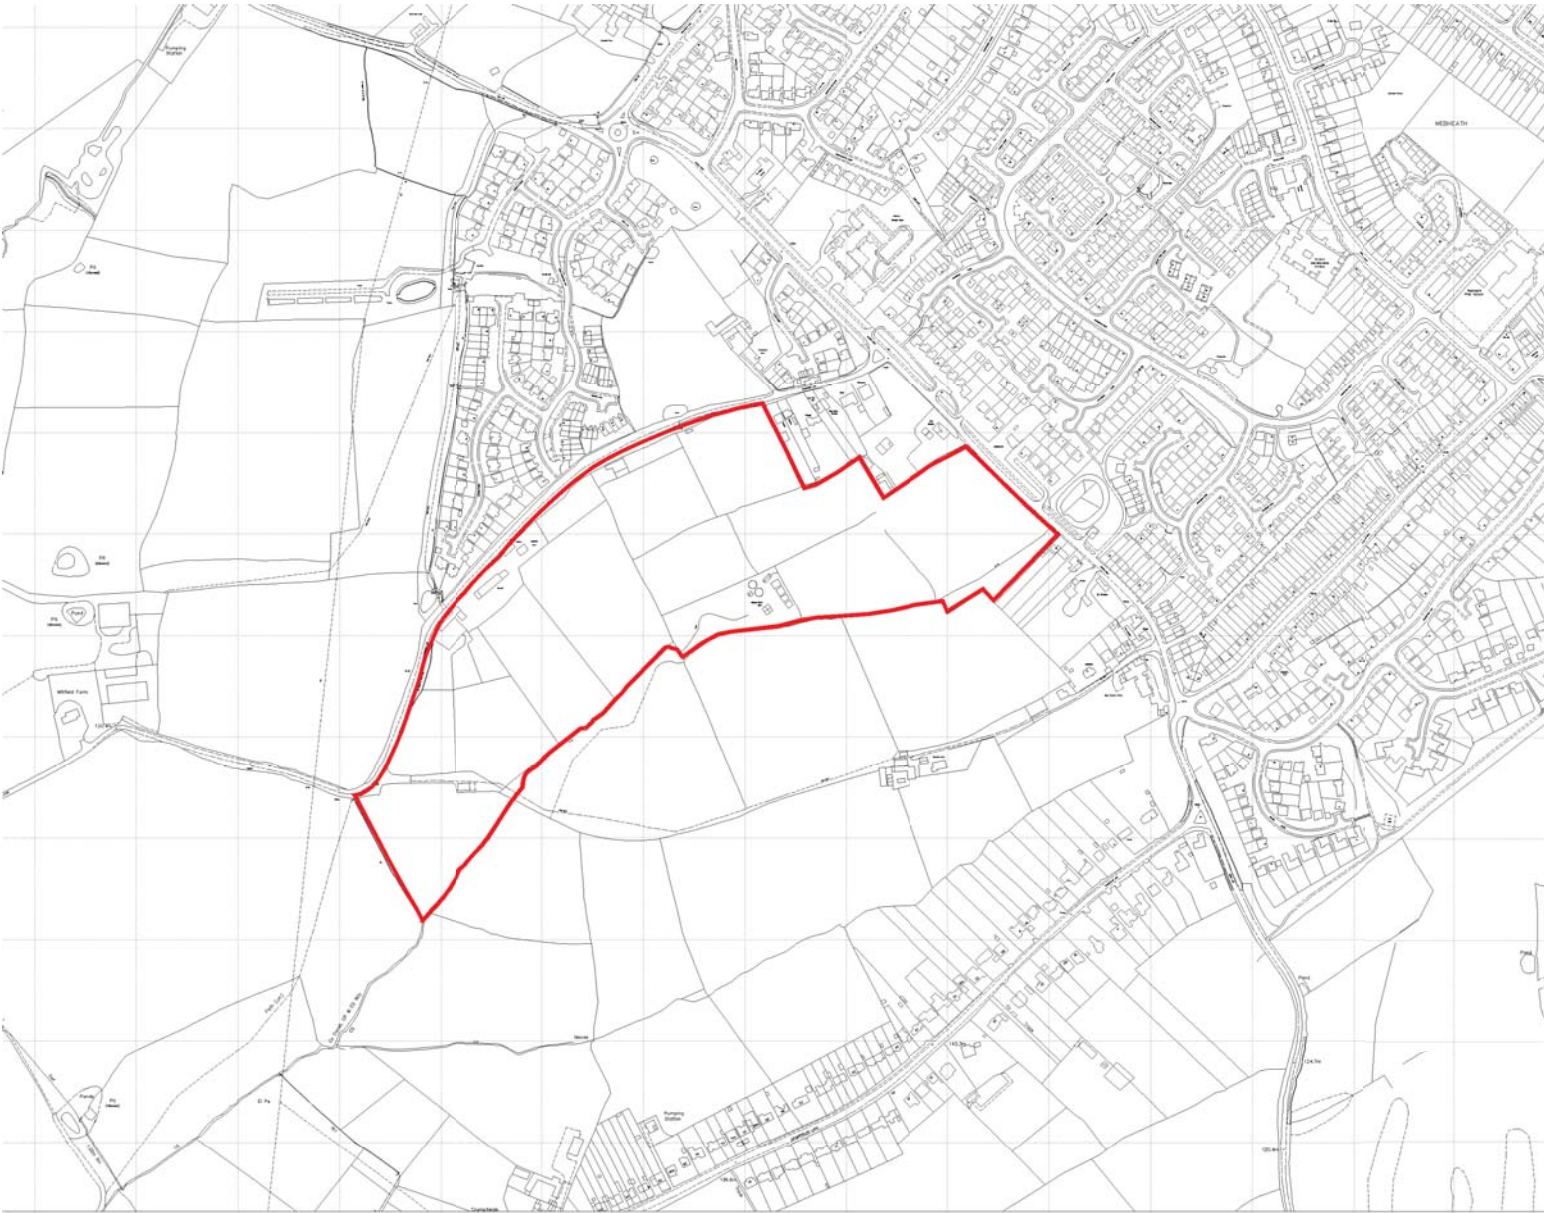
Figure 1. Site Plan

Site Boundary  
12.85 Ha / 31.75 Ac

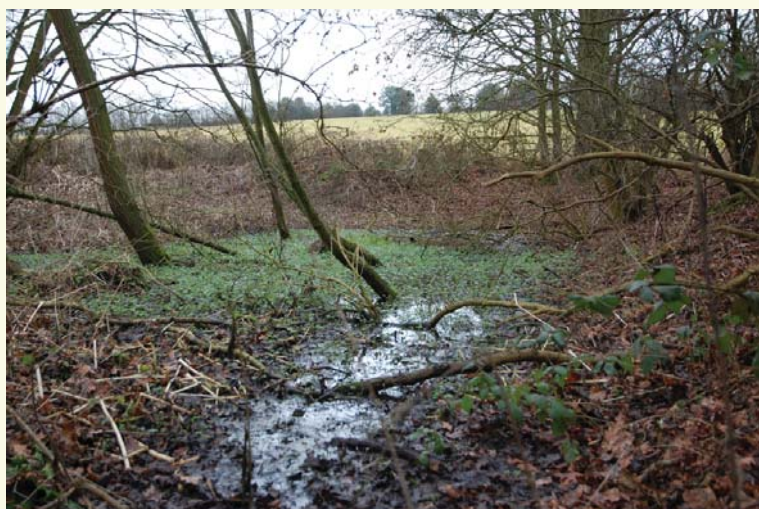
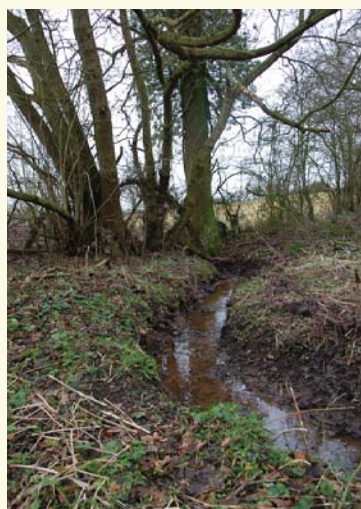
3.6 The site has been checked against the Environment Agency Flood Maps which are available from the Environment Agency website and the results are shown on page 13:

3.7 The flood map on the previous page shows the site is located within Flood Zone 1, with a flood risk of less than 1 in 1000 year annual probability of flooding from fluvial rivers. The proposed development is to consist of residential dwellings and therefore using table D.2 Flood Risk Vulnerability and Flood Zone ‘Compatibility’ from PPS25 the development is classified as ‘more vulnerable’. Table D.3 in PPS25 (see below) states ‘more vulnerable’ development is sequentially acceptable in Flood Zone 1 and therefore an exception test is not required.

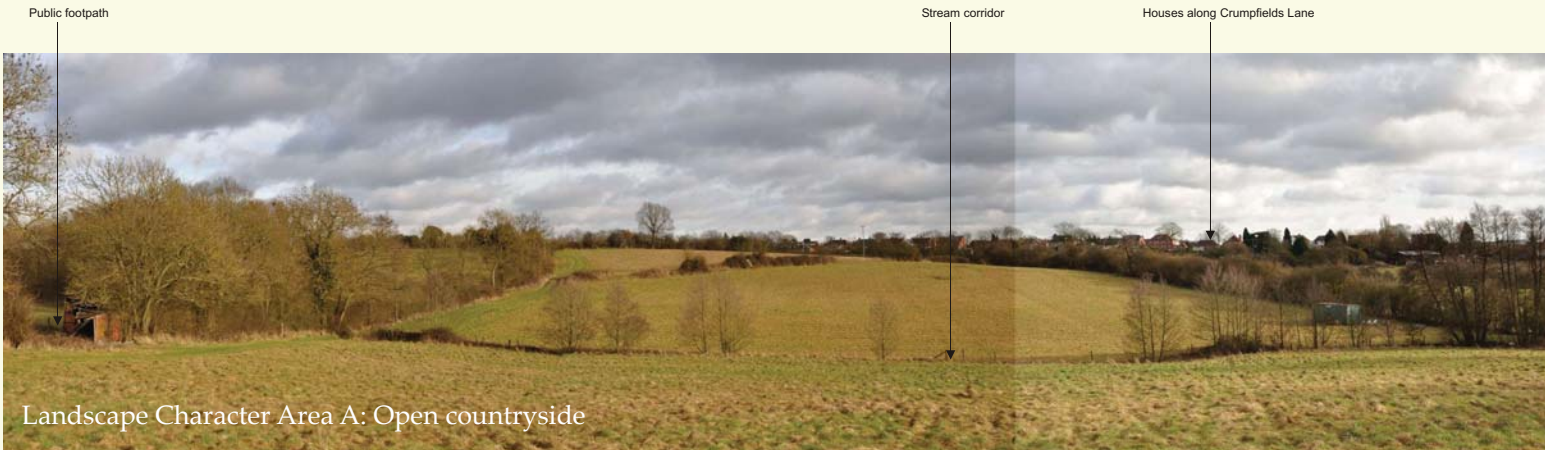
Viewpoint A1: GentlySloping large scale fields with views to and from the east, crossed by low hedgerows and sparsely vegetated stream corridor

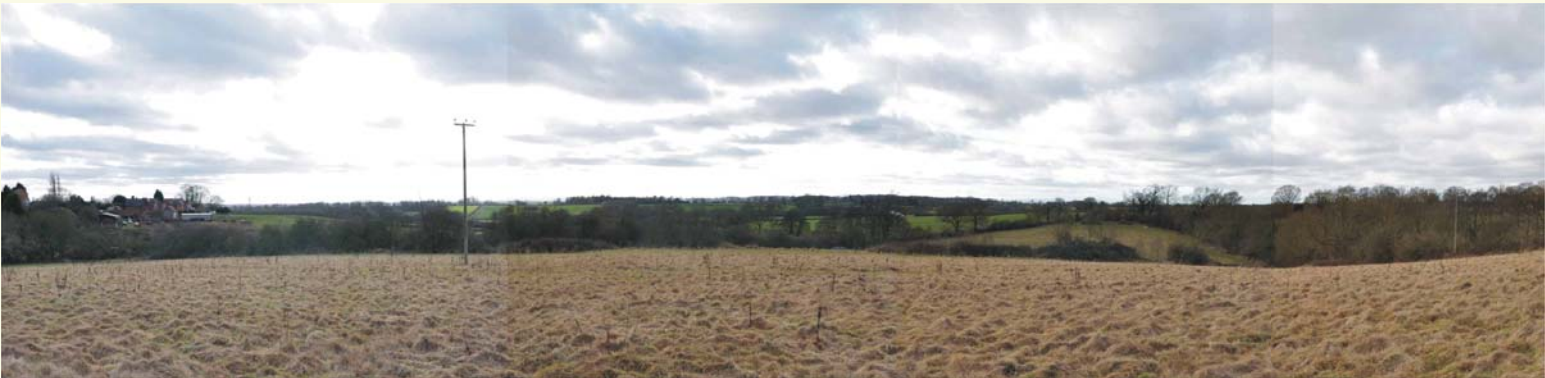
Viewpoint A2: Open views possible of surrounding countryside; from this elevated position

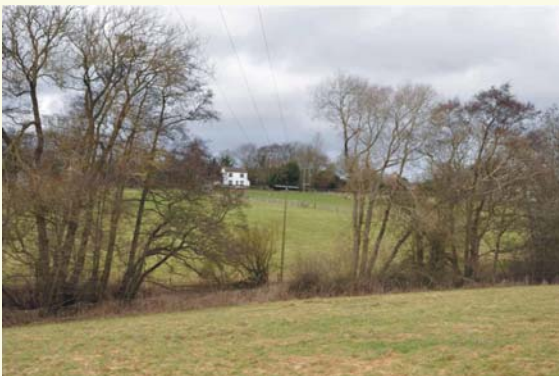
Viewpoint B1: Land falls from the south-east and north-west, towards densely vegetated stream corridor in the centre

- **Gently sloping partially enclosed agricultural fields:** (see viewpoints B1 and B2). This character area comprises land gently sloping towards the densely vegetated stream corridor which runs along its southern edge. The farm is a feature along the northern edge, and the farmhouse has open views into the area. The stream corridor is a focus; rich in landscape, ecological and archaeological value.

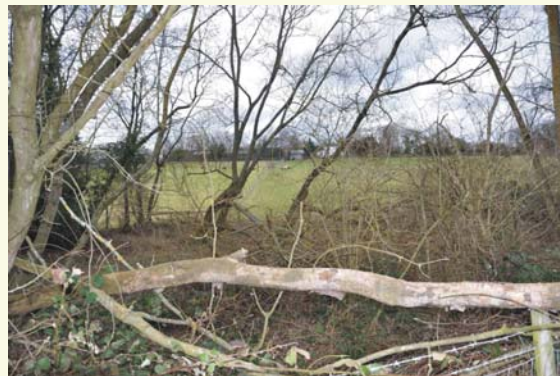
Viewpoint B2: Densely vegetated stream corridor is dissected by overhead powerline. Farmhouse on Pumpouse has open views into character area

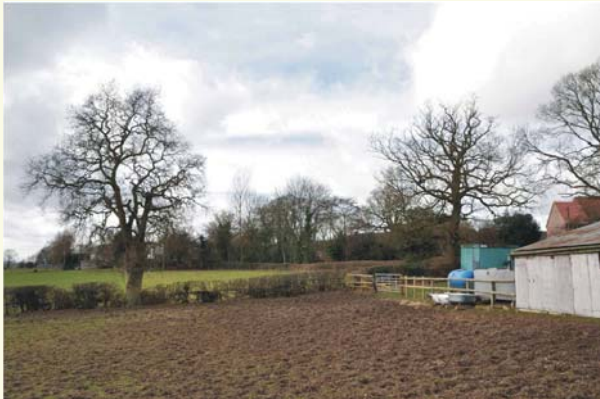
Viewpoint C1: Land used for agriculture

- **Enclosed agricultural fields:** (see viewpoints C1-C3). This character area comprises a network of hedgerows containing trees of moderate and high landscape value defining a small field pattern. Backs of property gardens along Pumphouse Lane enclose the area to the north east.

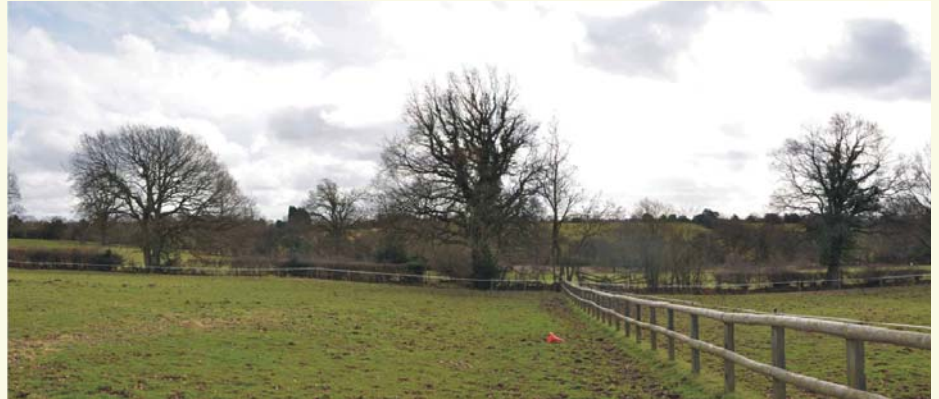
Viewpoint C2: A network of hedgerows containing trees of moderate and high landscape value

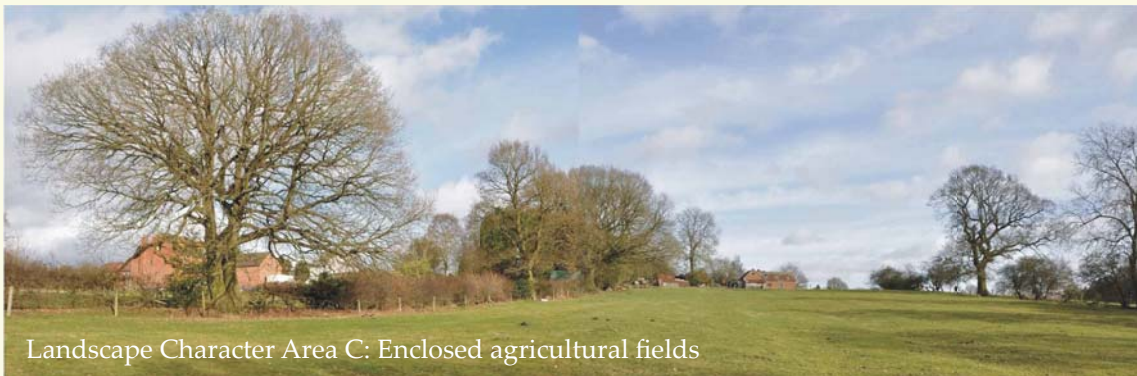
Viewpoint C3: Landscape is enclosed to the south by trees in property gardens along Pumphouse Lane

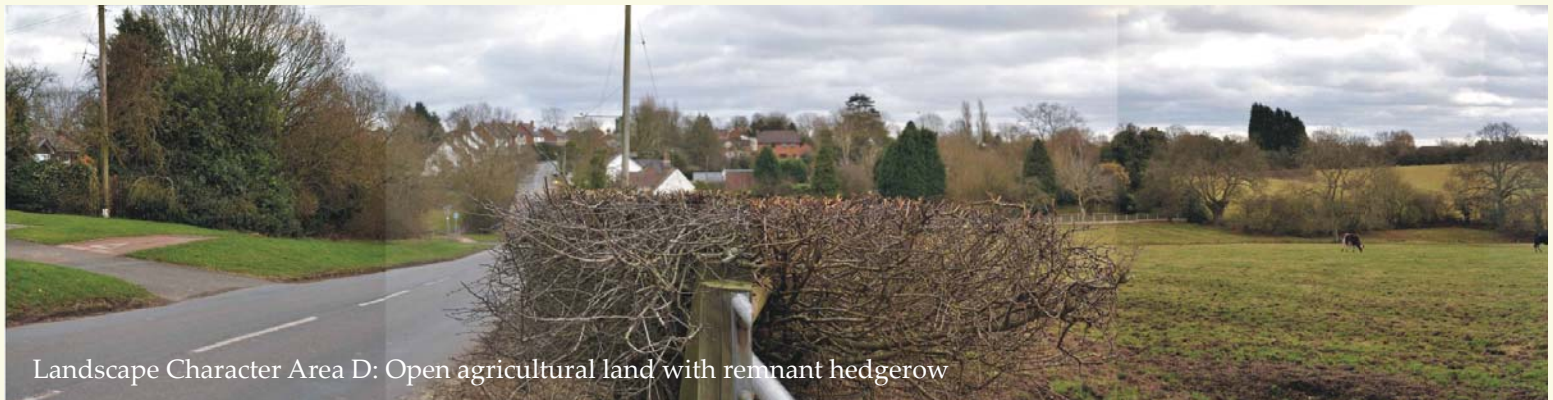
Landscape Character Area D: Open agricultural land with remnant hedgerow

Viewpoint D1: Open grazed fields bound on its eastern edge by a low clipped hedgerow allowing views into the site from Church Road

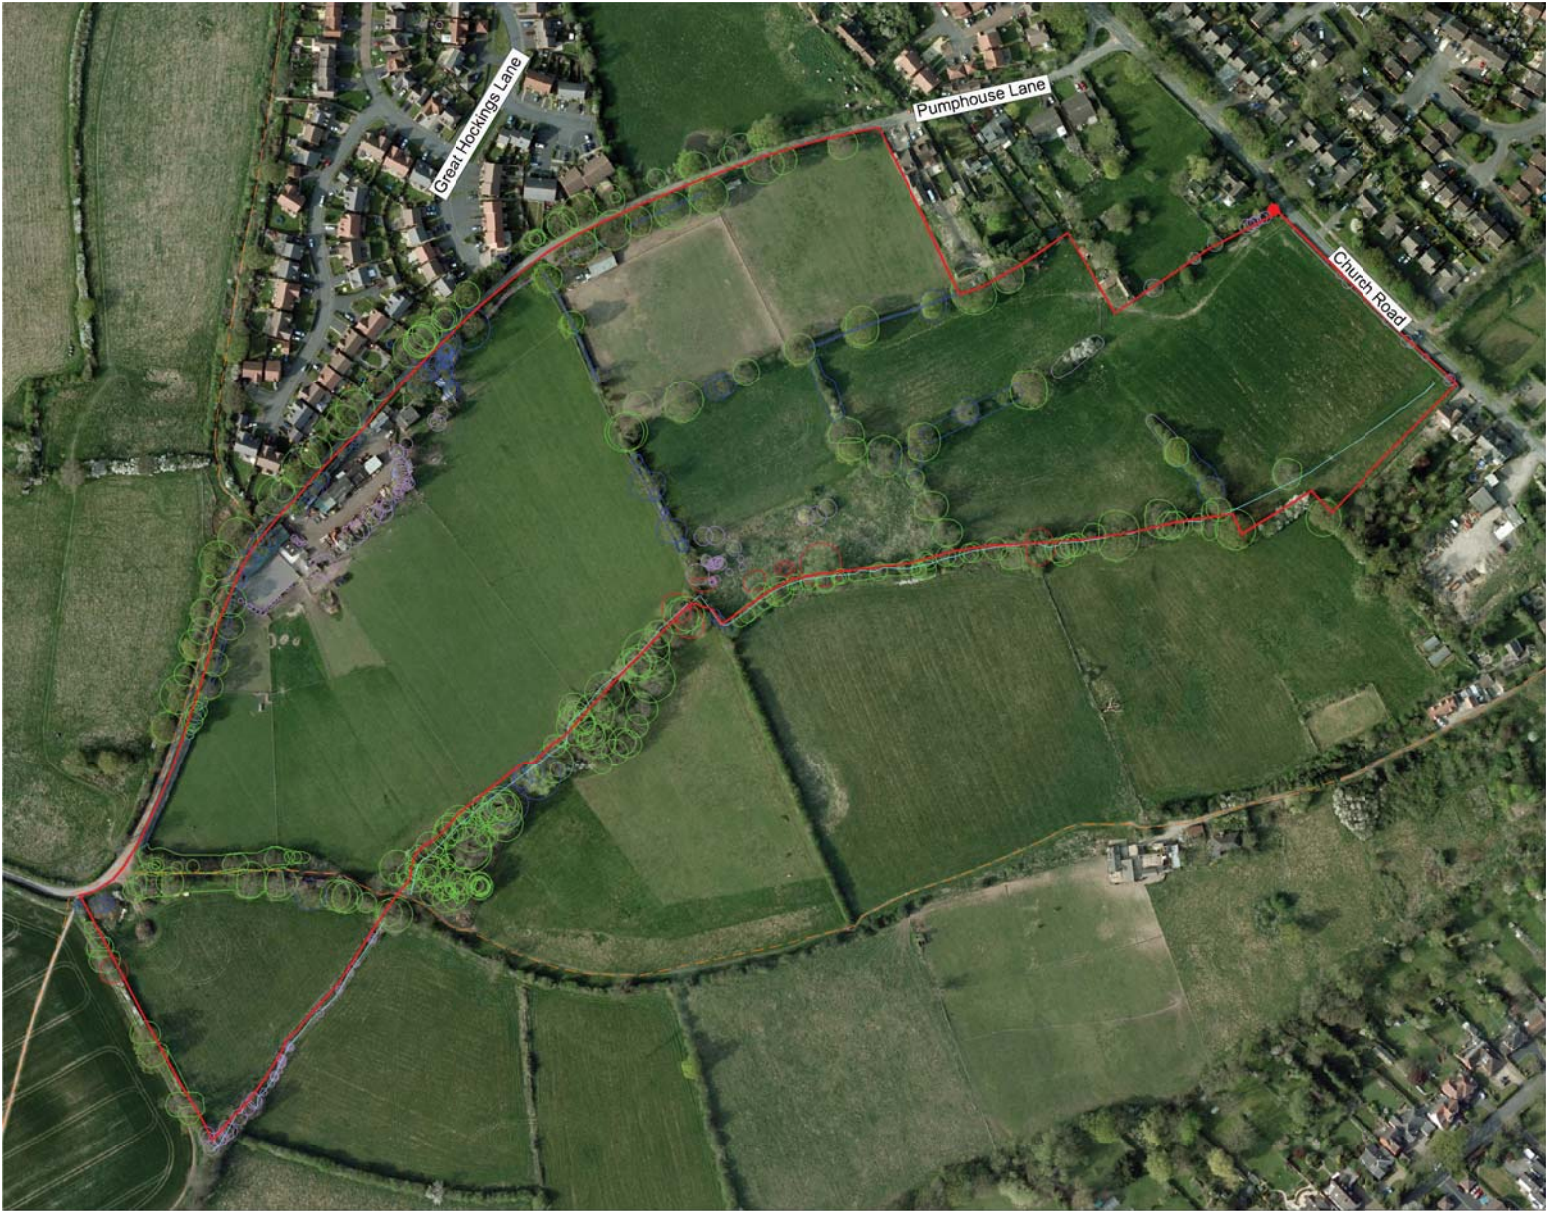
Figure 13. Landscape Features

- **High landscape value trees/hedgerows:** To be retained for their landscape importance and character.
- **Moderate landscape value trees/hedgerows:** Retain if possible. Trees making a contribution to the landscape setting and landscape character.
- **Low landscape value trees/hedgerows:** Tree groups/ individuals which make little contribution to the landscape setting and character.
- **Grade R trees:** recommended for removal for arboricultural reasons.

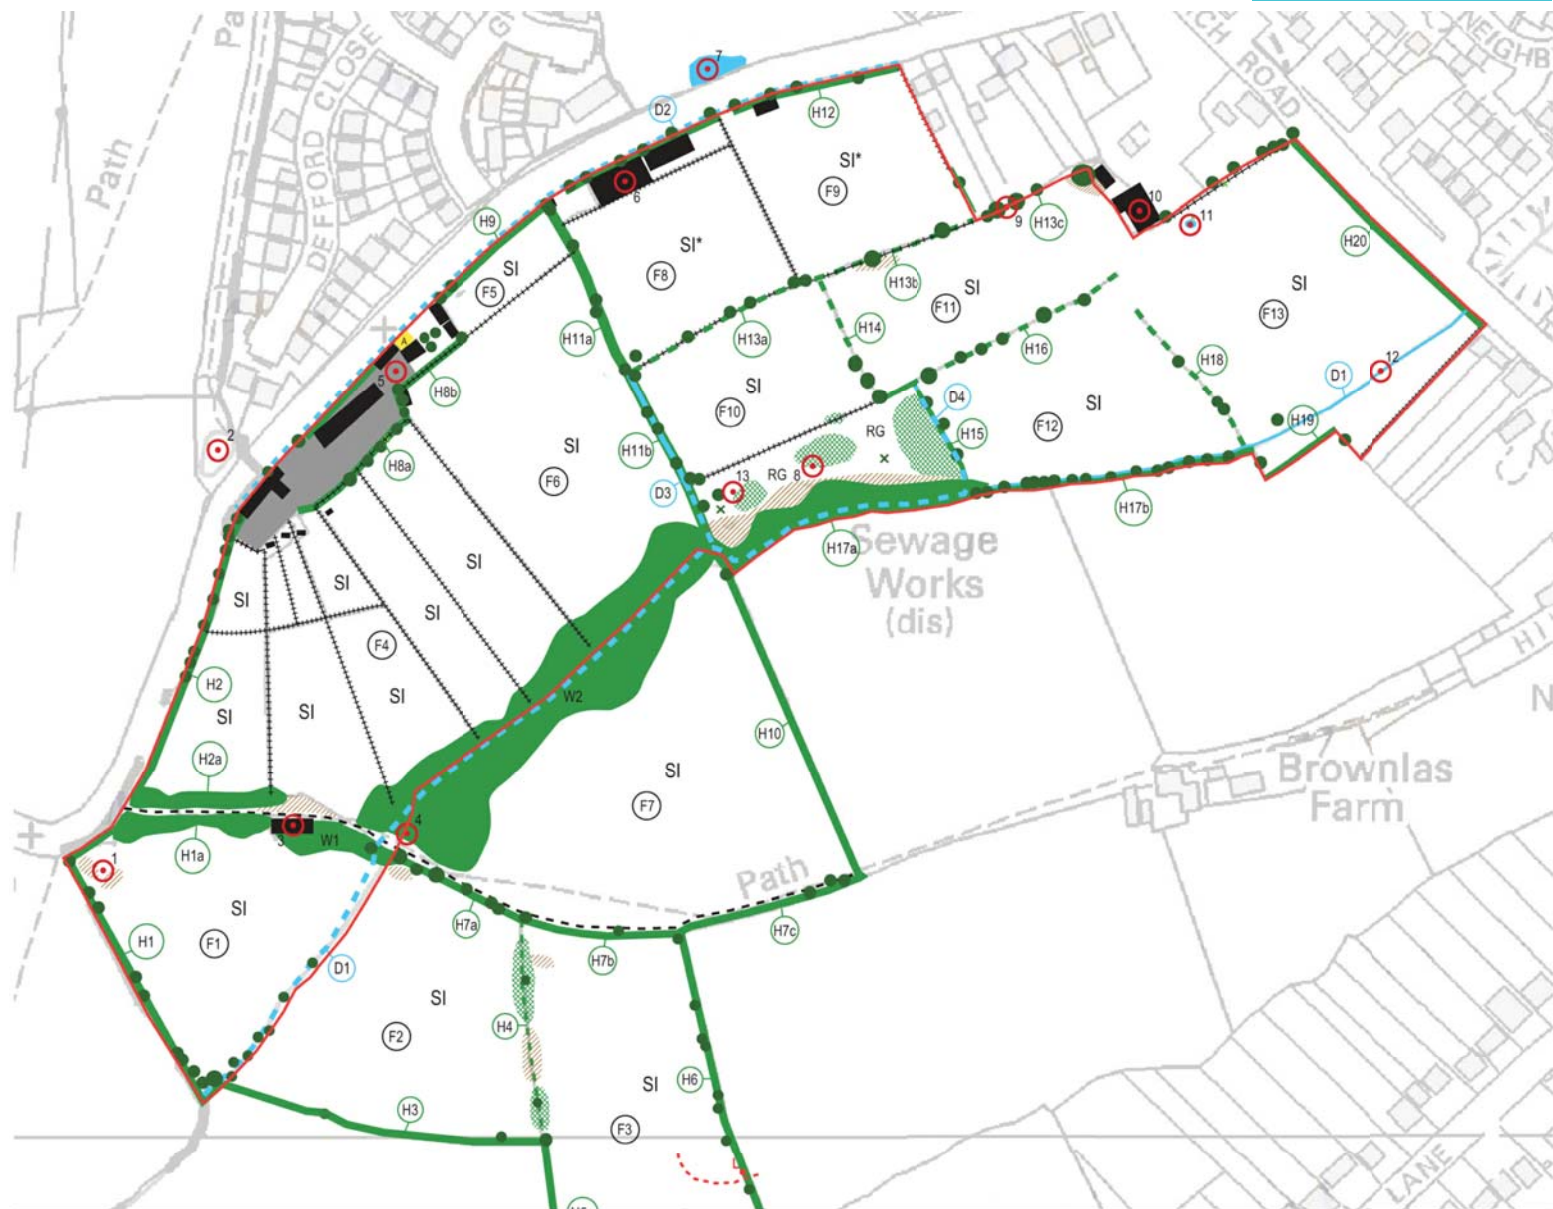
Figure 16. Habitat Plan

6	Horse paddocks and stables
7	Pond (off site)
8	Disused sewage works
9	Large brash/log piles adjacent to dilapidated garden
10	Old barn buildings (off site)
11	Standing water caused by heavy cattle trampling
12	Brook (D1)
13	Outlier badger sett

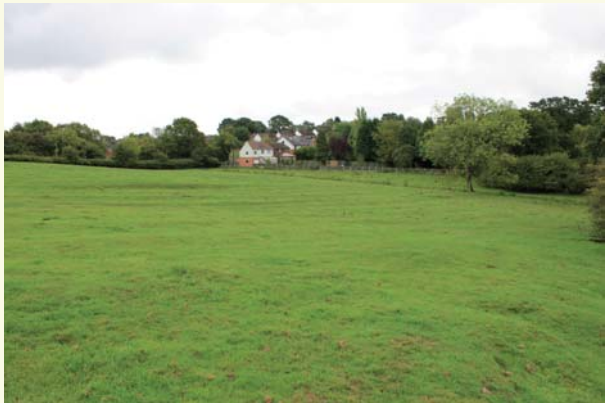
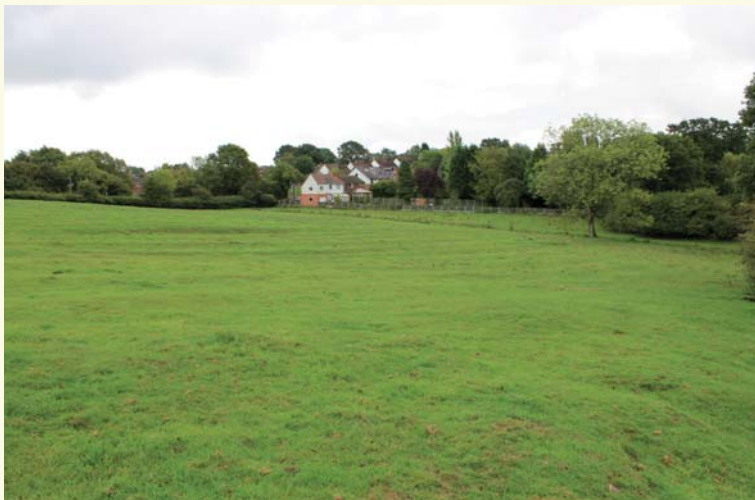
Ridge and furrow in field fronting Church Road (looking SE)

3.331 The general impression is that the application site and its surroundings contains visible elements (in the form of ridge and furrow earthworks, field boundaries and a former trackway) of a Medieval and Post Medieval agricultural landscape. The date of the water management earthworks is not known although those to the east are possibly of Post Medieval origin. Initial

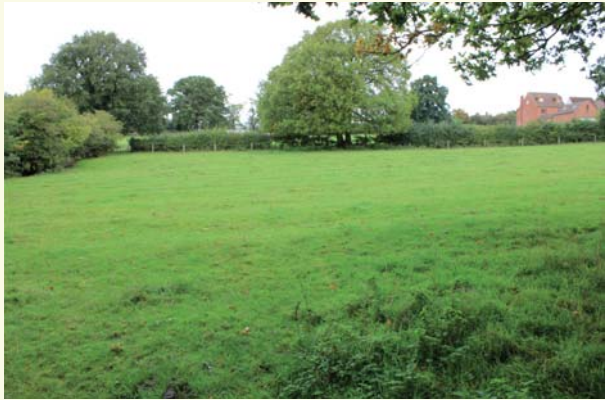
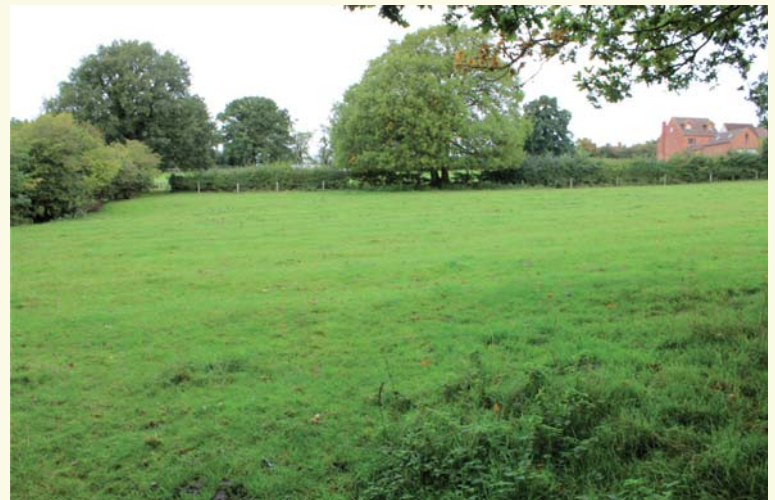
Ridge and furrow in field NE of former sewage works (looking N)

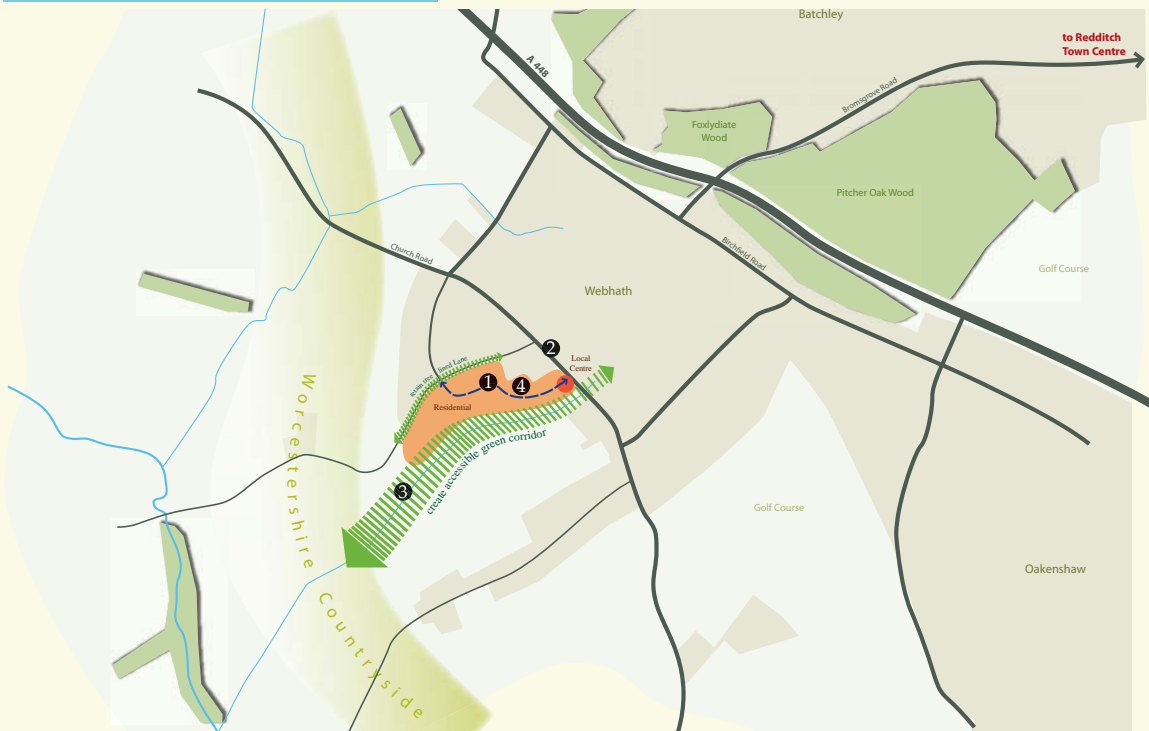
Figure 25. Wider Concept Diagram

Lane should be retained for its distinctive character. The densely vegetated brook forms a vital green corridor and retains archaeological features alongside it, which need to be protected. To mitigate impact on the newt pond in the north, a development stand off should be considered. The main access to the site will be off Church Road and a link to Great Hockings Lane and its associated housing development will be provided.
